EVALUATION OF CHURCH BUILDING CONDITION IN WEST JAKARTA USING CONDITION SURVEY PROTOCOL (CSP) 1 METHOD

Christobodos E. W. Marlissa^{1}, Hans Dermawan², Widsri Palamba³*

^{1,2,3} Civil Engineering Department, Faculty of Engineering and Computer Science, Kristen Krida Wacana University

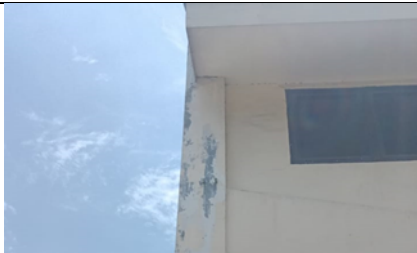
Table 11. Representative of Architectural Component

Component Architectural: Sub-Component Finishing

Condition Survey Protocol 1 Matrix Method			
Condition Value	Priority Value	Matrix Value	Color Code
3	2	6

The researchers assigned a condition score of 3 and a priority score of 2, noting that Table 11 explains peeling paint. The assessment considers the potential impact of paint peeling on the building structure and the external environment. Heavy rain could affect the columns or building structure, causing cracks due to dampness penetration if left unattended.

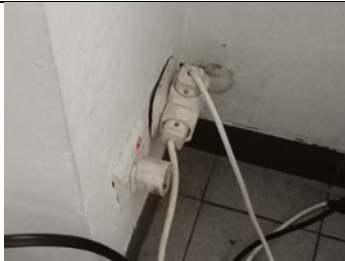
Table 12. Representative of Electrical Component

Component Electrical: Sub-Component Power Socket and Switch

Condition Survey Protocol 1 Matrix Method			
Condition Value	Priority Value	Matrix Value	Color Code
1	2	2

The researcher assigned a condition score of 1 and a priority score of 2 to the power socket, which was found to be in a loose condition, although still functioning. The degradation of the socket casing, which may wear out or become detached, poses a potential long-term risk for users of the church building, such as the possibility of electric shock due to plugging and unplugging devices.
