EVALUATION OF CHURCH BUILDING CONDITION IN WEST JAKARTA USING CONDITION SURVEY PROTOCOL (CSP) 1 METHOD

Christobodos E. W. Marlissa^{1}, Hans Dermawan², Widsri Palamba³*

^{1,2,3} Civil Engineering Department, Faculty of Engineering and Computer Science, Kristen Krida Wacana University

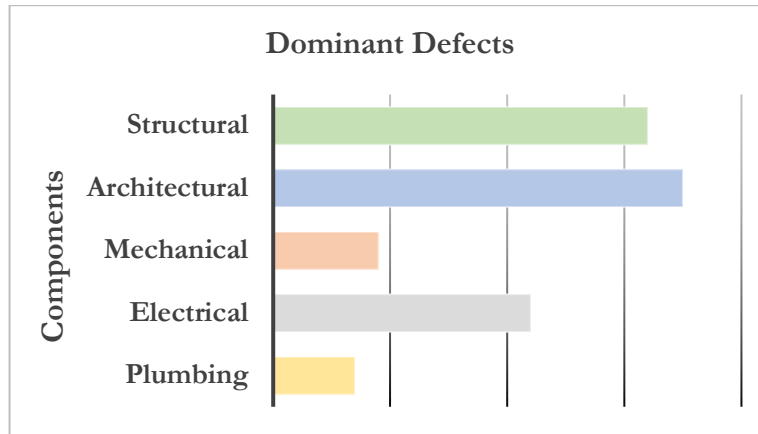
Figure 3. Types and Dominant Defect.

According to Figure 3, architectural component defects are the most common issue in church buildings. These defects are characterized by color changes or discolouration and peeling of paint. This phenomenon may be caused by climate conditions in West Jakarta. Structural components ranked second in terms of defect occurrence, with an average defect size of cracks ranging from 0 to 1 millimeter. These defects could be attributed to suboptimal material quality, poor workmanship, or temperature fluctuations. Poor installation or dampness penetration causes a loose electrical socket detached from the wall to be the predominant defect in the third rank, although it still functions.

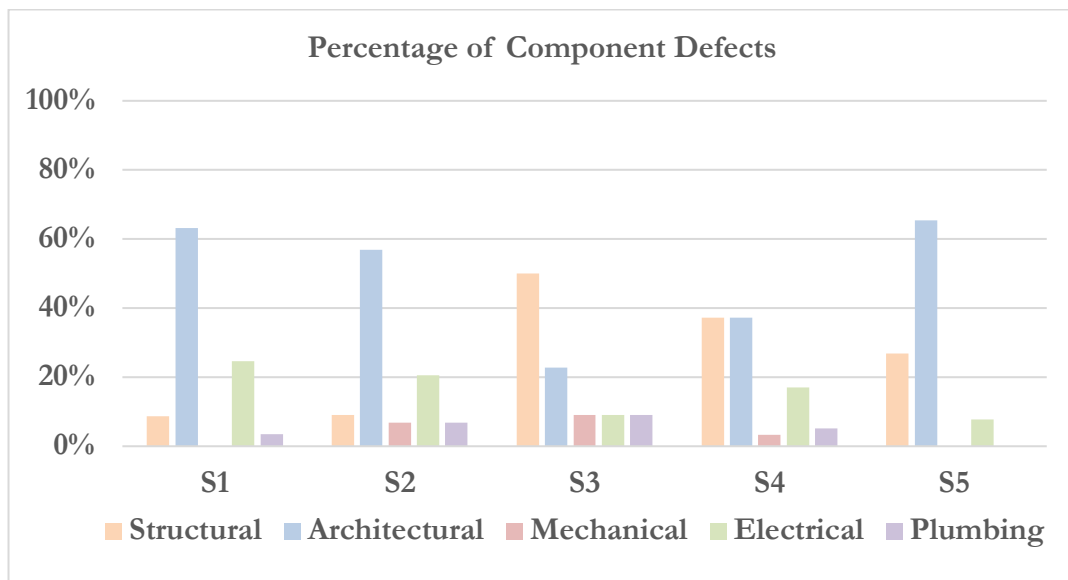
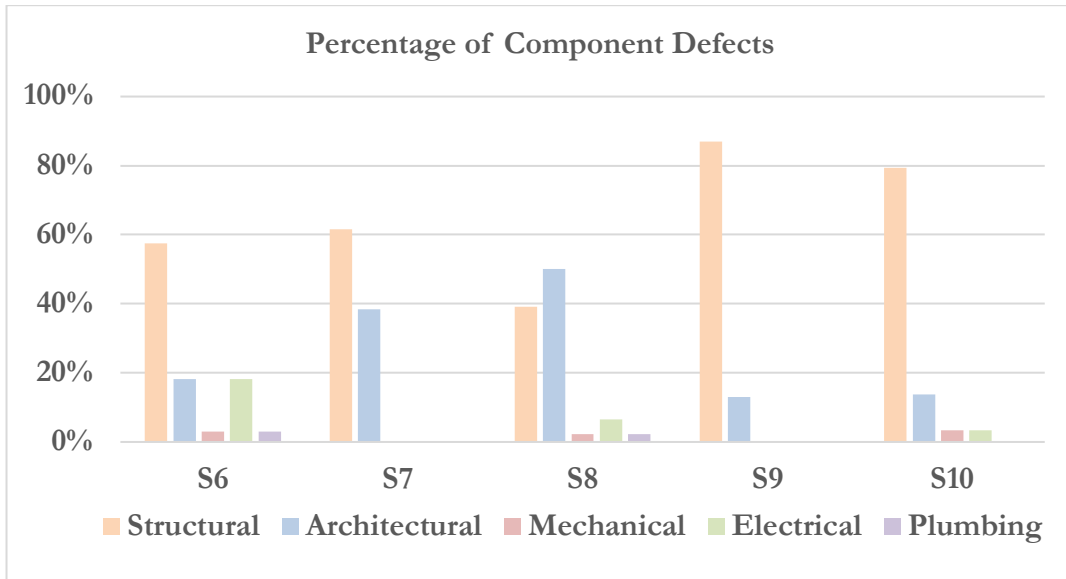
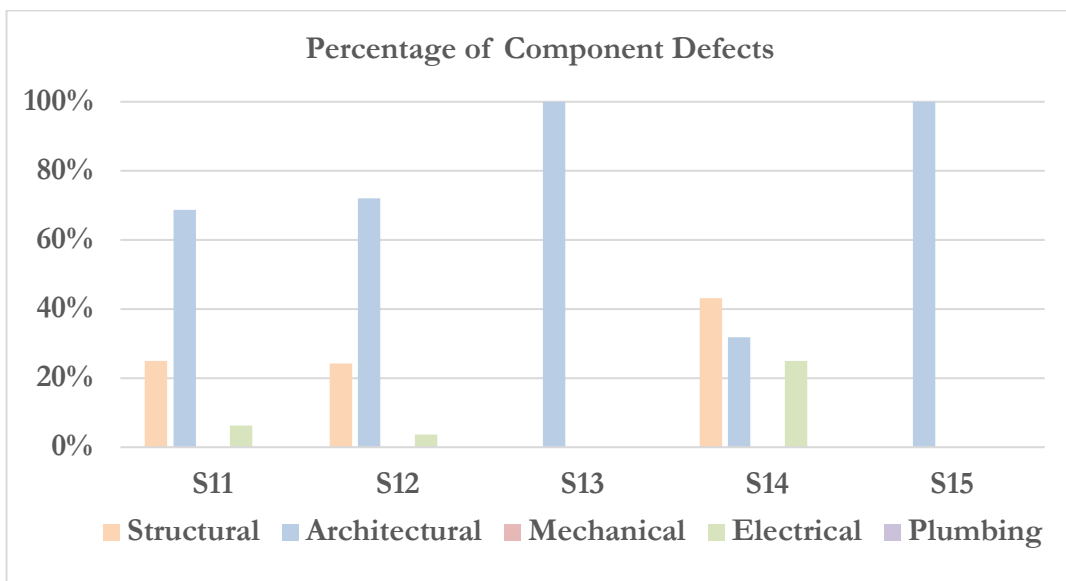
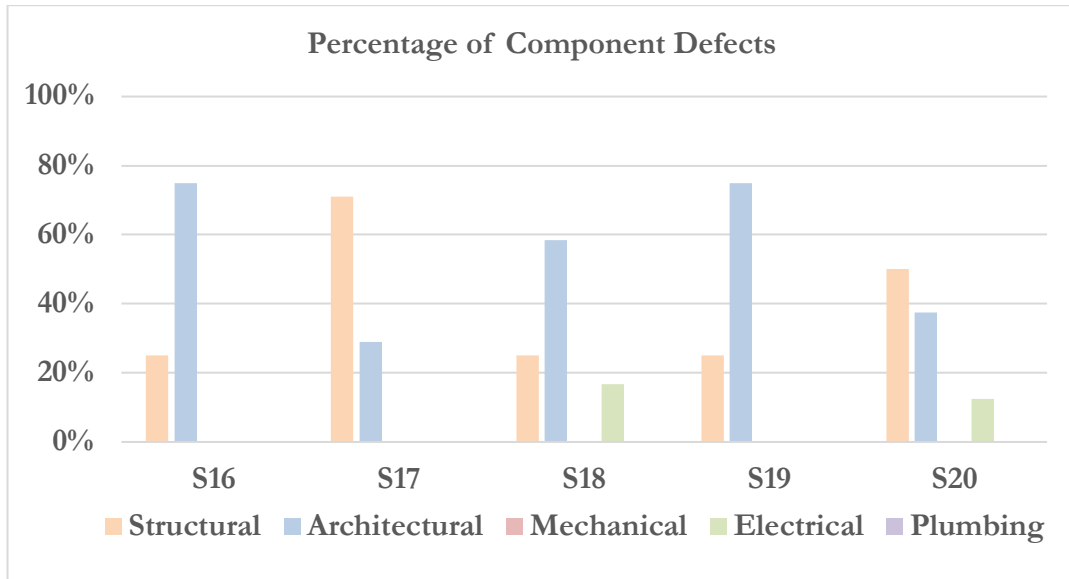
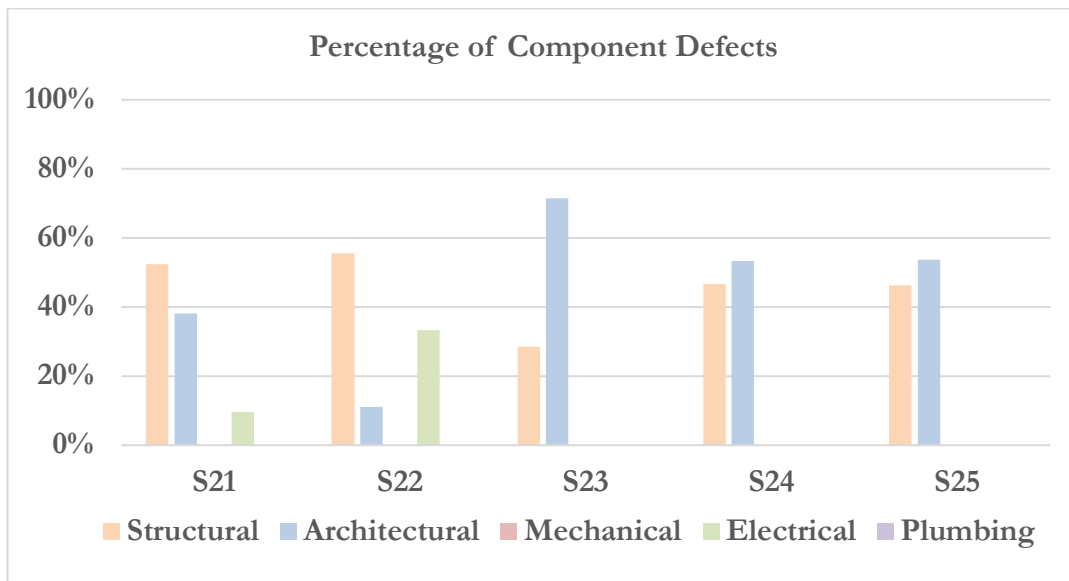
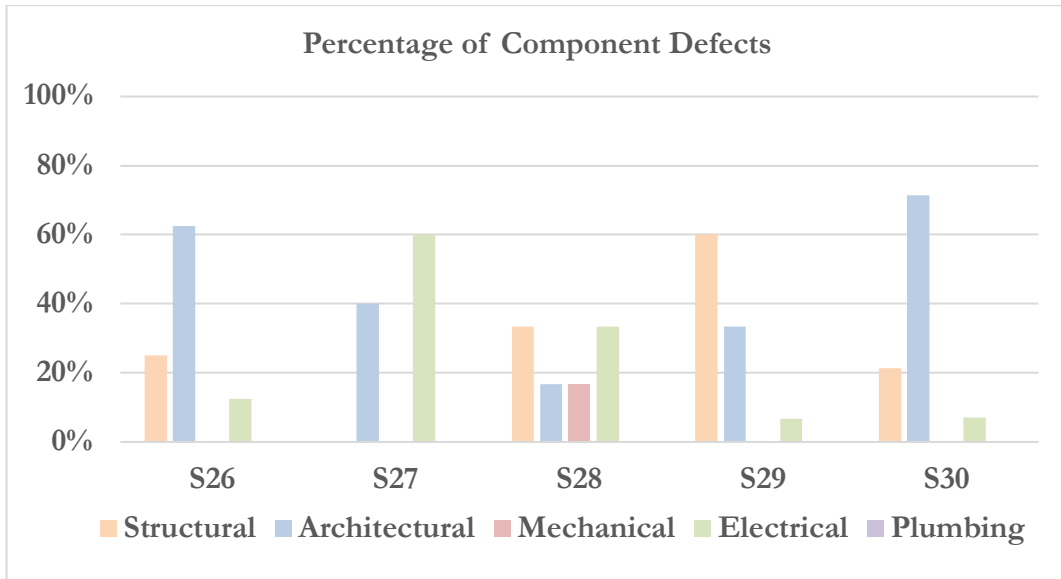
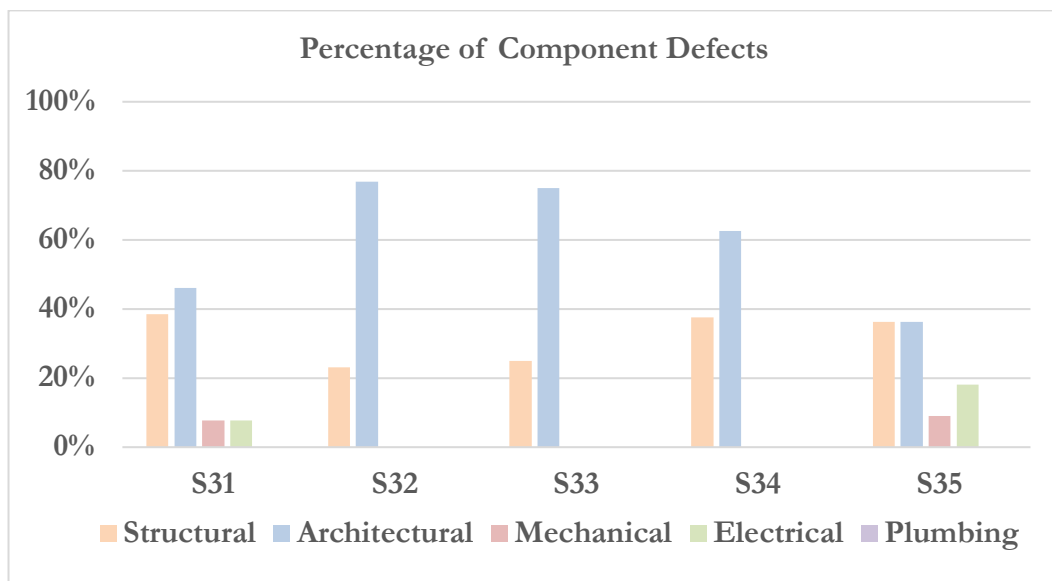
An analysis of Figures 4 to 10 reveals the extent of defect to the various components of the church building's. The data provides a comprehensive overview of the most prevalent types of damage, serving as a reference for conducting inspections and prioritizing repairs by the church and government for components with the highest damage percentages.

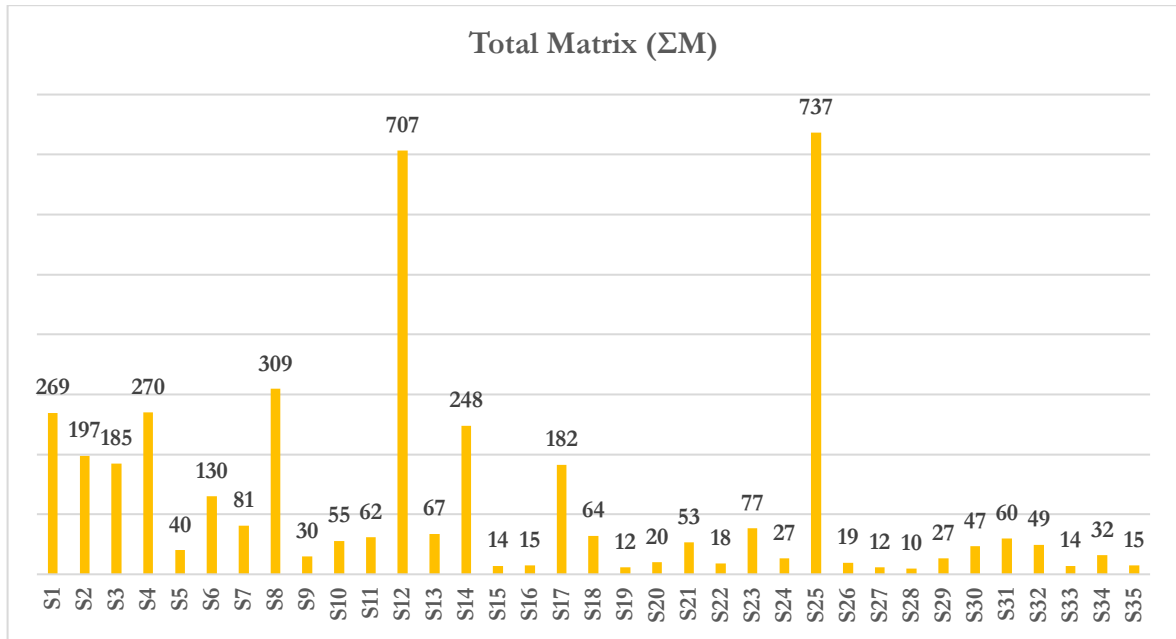
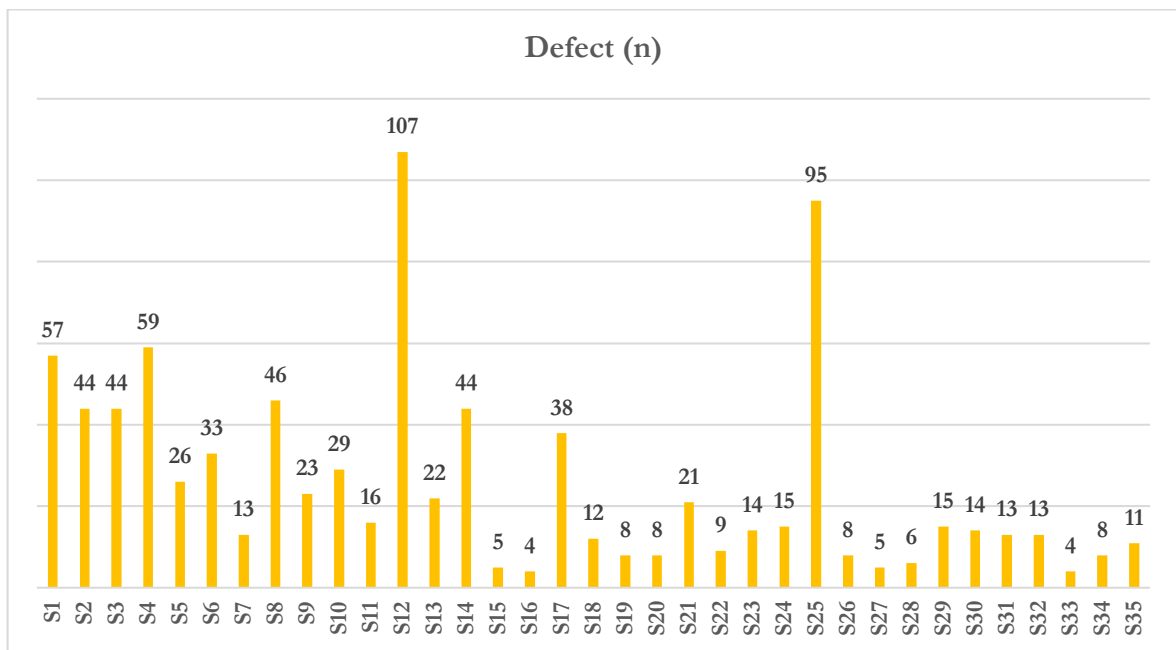
The analysis of Figure 11 and Figure 12 reveals variations in the quantity of matrix values and defect obtained from the research samples. The research object "S25" had the highest recorded total matrix value, reaching 737. The sample code "S12" had the highest damage count, reaching 107.

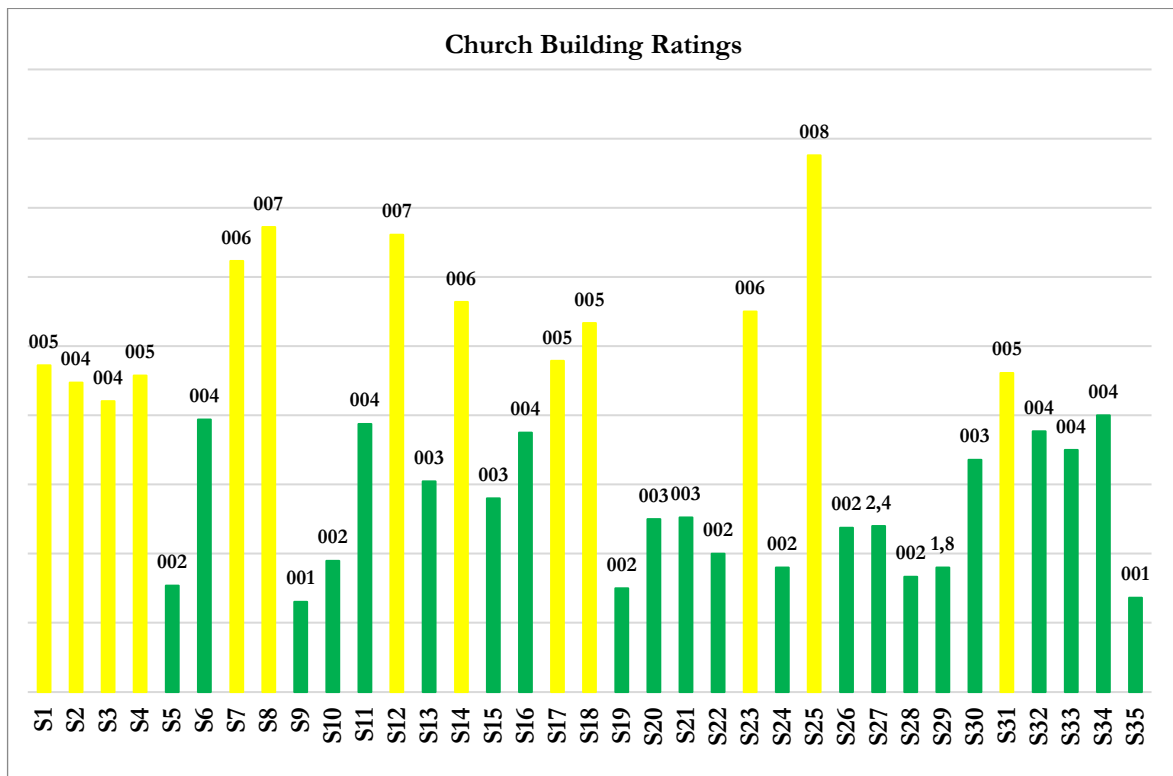
Figure 13. Overall Church Building Rating

According to Figure 13, sample code S25 in the Church Building has the highest score of 7.76. This is because of the high frequency of defects, such as cracks in the walls at multiple points, window decay caused by termites, and the aging of wooden materials in the roof structure. The research object "S25" is a 329 years old church, making it one of the oldest churches in West Jakarta.
